Helvetia Insurance Head Office

The west extension of the Helvetia Insurance building in St. Gallen is characterized by a cleverly coordinated irregularity, particularly in the form of differently inclined, storey-high window surfaces. The building thus blends smoothly into its surroundings.

Area	Architecture
Location	St.Gallen, CH
Year of manufacture	2017
Architect	Herzog & de Meuron LTD.

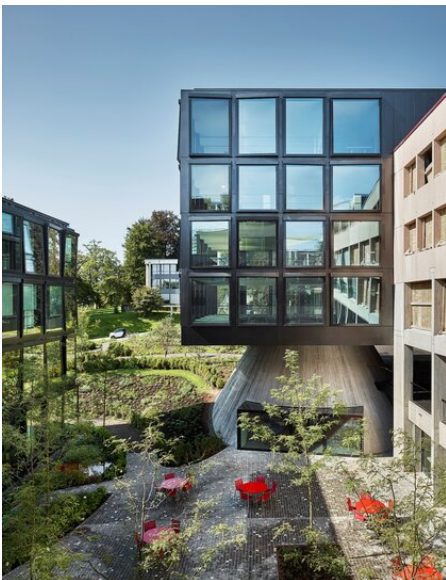
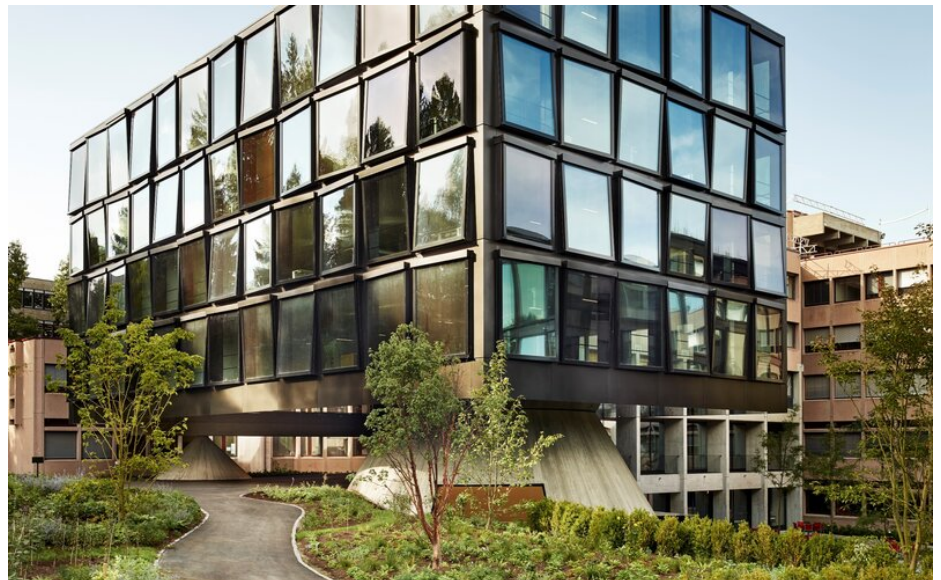
The newly constructed, block-like building extends the existing office complex to the west and is supported on two imposing concrete cones due to its hillside location. The unusual façade concept is dominated by floor-to-ceiling windows that project sculpturally from the façade plane at different angles. This artistic kaleidoscope reflects the surroundings in a sophisticated way - be it the sky, the garden or the immediate surroundings.

Another important element is the sun protection system, a special version of the 6011 façade awning from Kästli Storen, which was developed in collaboration with Herzog & de Meuron and the façade planner Emmer Pfenninger. The basic requirement was that the sun protection system should affect the unique façade concept as little as possible and ideally remain invisible. This was achieved by the almost seamless integration of the awning cassette into the framed window element, each of which protrudes to different heights.
