Helvetia Insurance Head Office

The west extension of the Helvetia Insurance building in St. Gallen is characterized by a cleverly coordinated irregularity, particularly in the form of differently inclined, storey-high window surfaces. The building thus blends smoothly into its surroundings.

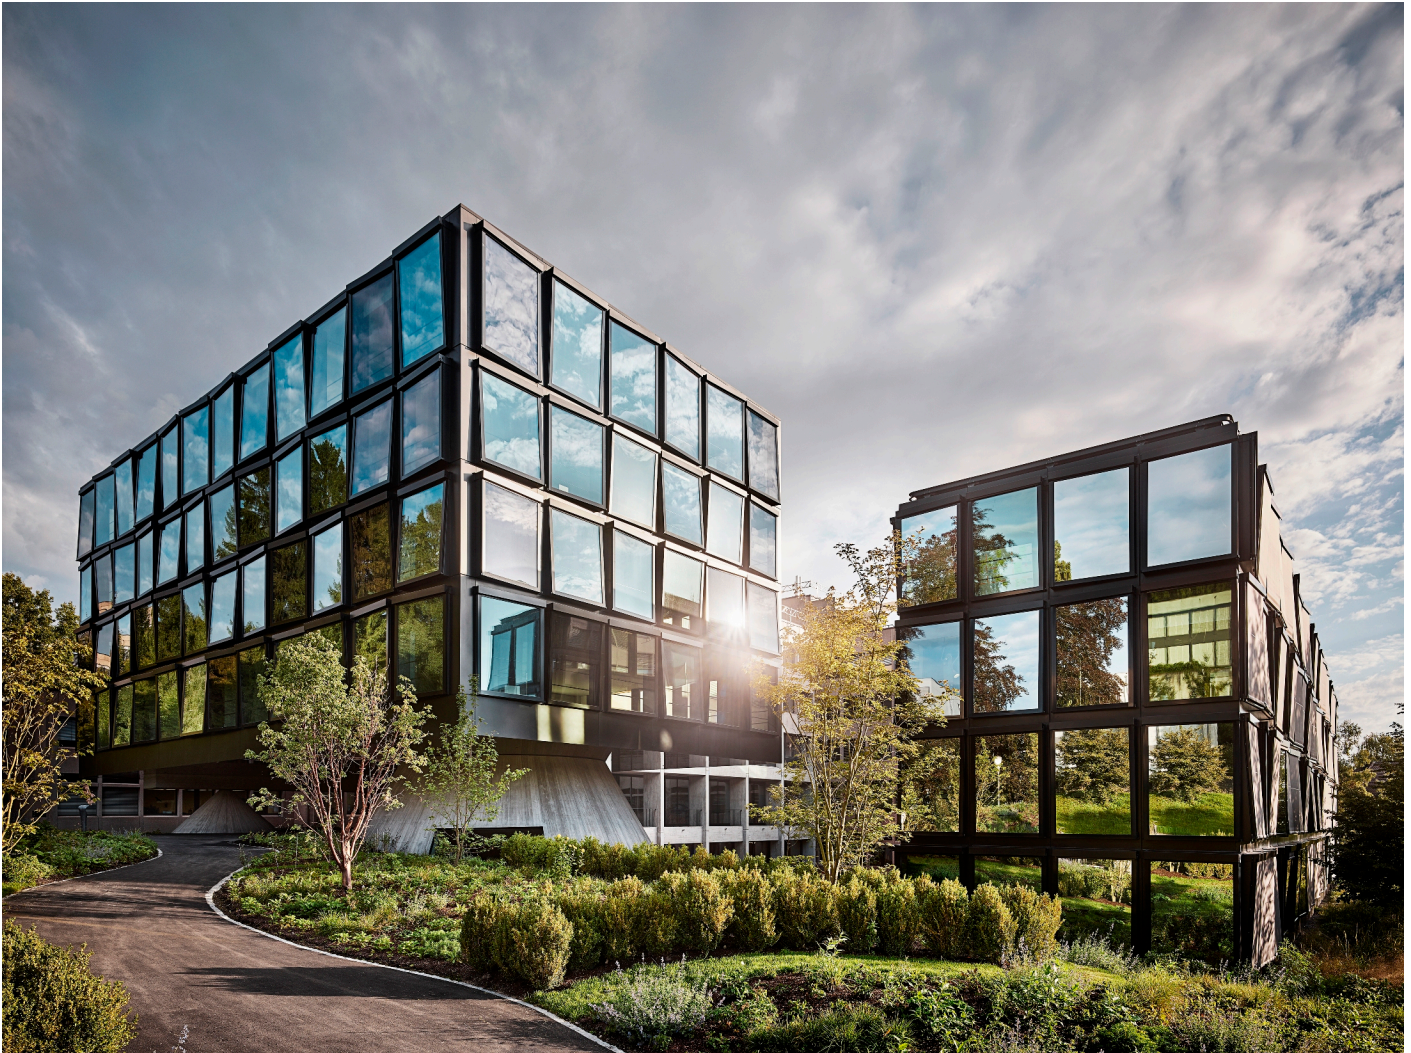
The newly constructed, block-like building extends the existing office complex to the west and is supported on two imposing concrete cones due to its hillside location. The unusual façade concept is dominated by floor-to-ceiling windows that project sculpturally from the façade plane at different angles. This artistic kaleidoscope reflects the surroundings in a sophisticated way - be it the sky, the garden or the immediate surroundings.

Another important element is the sun protection system, a special version of the 6011 façade awning from Kästli Storen, which was developed in collaboration with Herzog & de Meuron and the façade planner Emmer Pfenninger. The basic requirement was that the sun protection system should affect the unique façade concept as little as possible and ideally remain invisible. This was achieved by the almost seamless integration of the awning cassette into the framed window element, each of which protrudes to different heights.
